Project Descriptions

Carrier Beam

Carrier Beam Failure

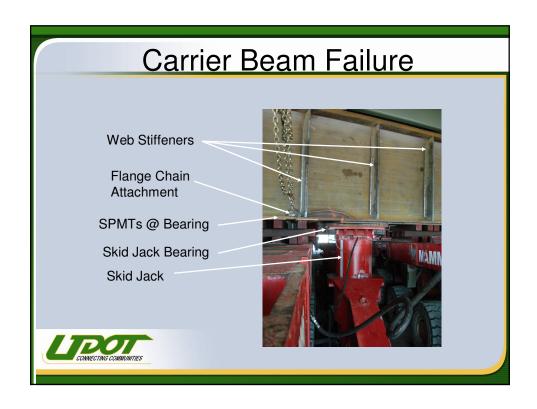
Structure @ Highland with Original Carrier Beams

- Structure weight transferred to skid jacks
- Location of carrier beam experiencing structural distress

- Failure Analysis
 - Load double from 4 SPMTs to 2 Skid Jacks
 - Discontinuous additional bottom plate
 - Stress concentration
 - Flange elastic bending
 - Web crippling
 - Twist of double beam

Retrofit of Carrier Beams at Highland before Transporting back to Bridge Farm

- 4 Web stiffeners added
- Additional Bottom Plate
 - Between Skid Jacks and No 1 & 4 SPMT units
 - Plate Dimension 1" x 24" x 5'
- Approx ½ the twist removed
